**CORRECTED COPY
Inspection Report**

Subject: Henry County
(Hooppole)

Prophetstown Pork, LLC.
26310 N. 2800th Ave.
Prophetstown, IL 61277

Date: May 5, 2011

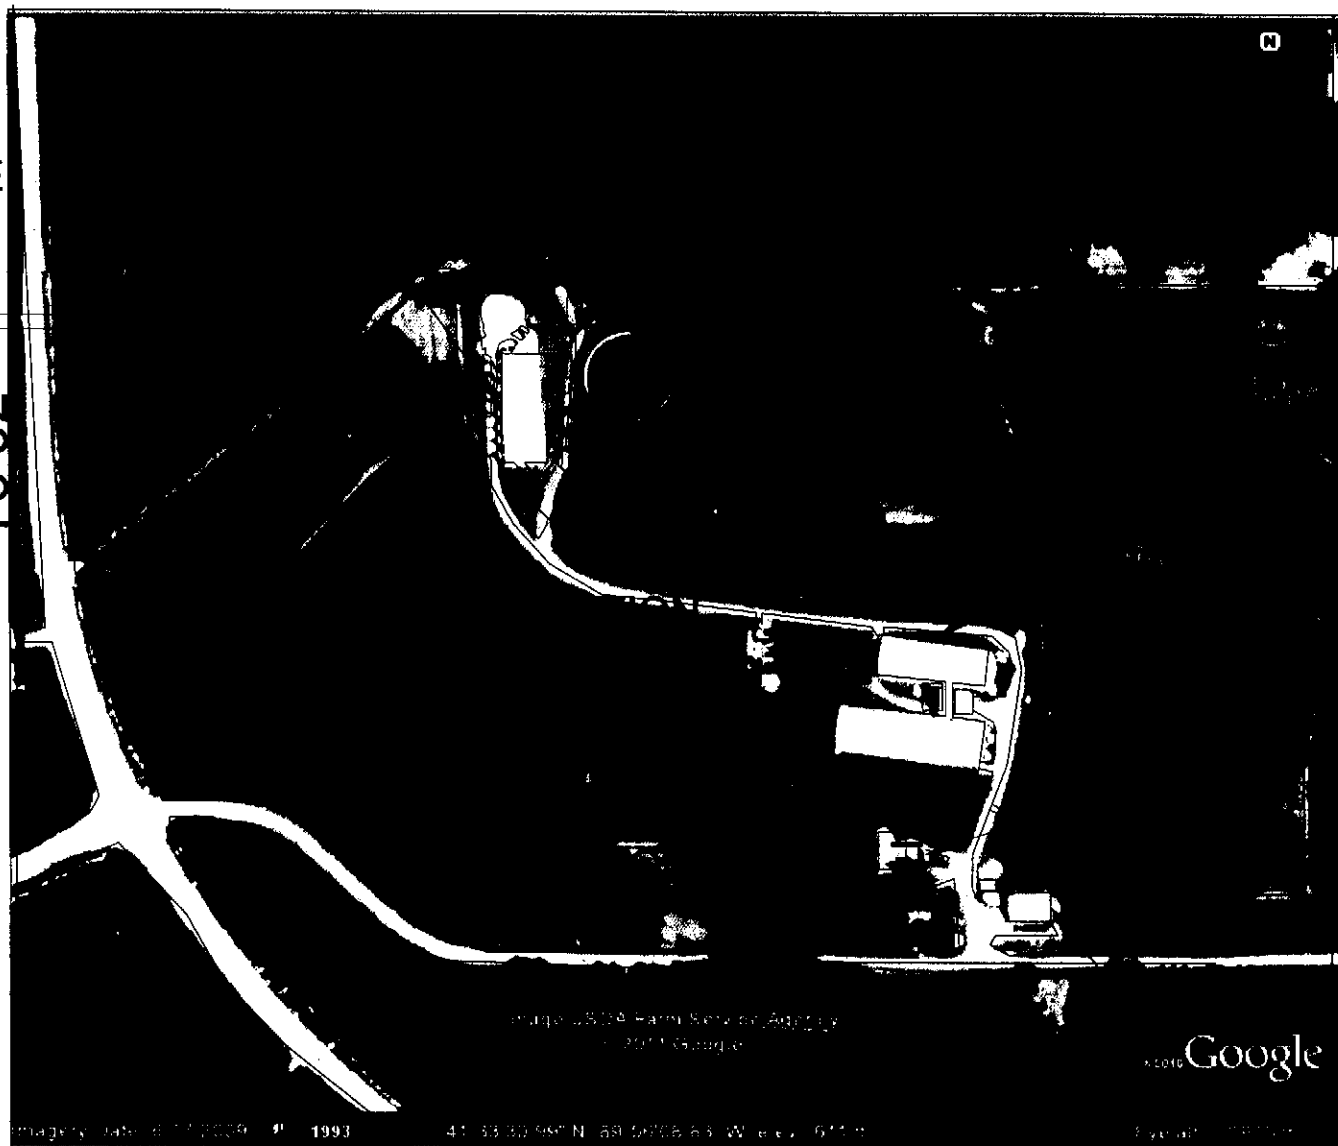
Figure 2. Plan View From Google Earth of Prophetstown Pork, LLC. on May 5, 2011.

Below is a detailed description of the buildings located on the above site. Please see Figure 2 for visual of buildings locations.

This building was just added in December 2010, it is equipped with tunnel ventilation. It can hold 1200 head sows and a total of 1400 head with the pins including the gilts. This building has the dimensions of 240'X78' and was built with an 8' deep pit along with a perimeter tile. This is the only known building on the facility to have a perimeter tile, and the outlet is to the northwest side of the concrete basin (see Figure 2.)

To easy the process of emptying the concrete basin a dedicated pipeline has been added under Roadway 92 on the west side of the property (see Figure 2.) This dedicated pipeline allows for quick and safe hookups for the hose used to remove the waste for land application.

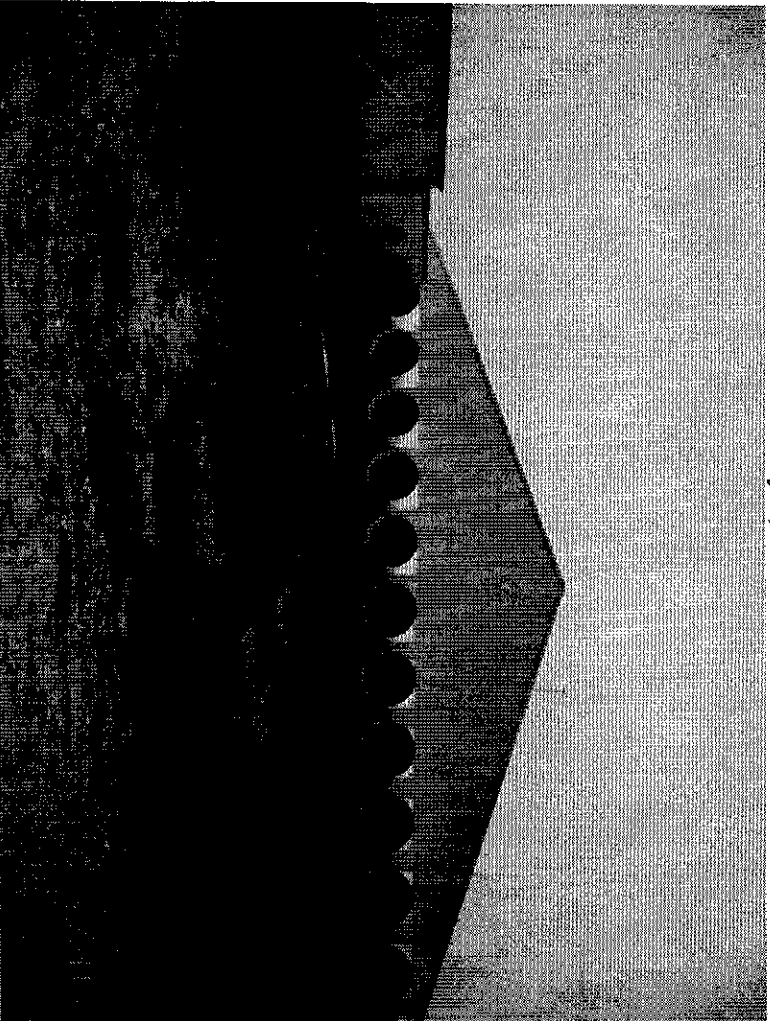
Photograph #5. New Gestation Building Tunnel Ventilation. View is south

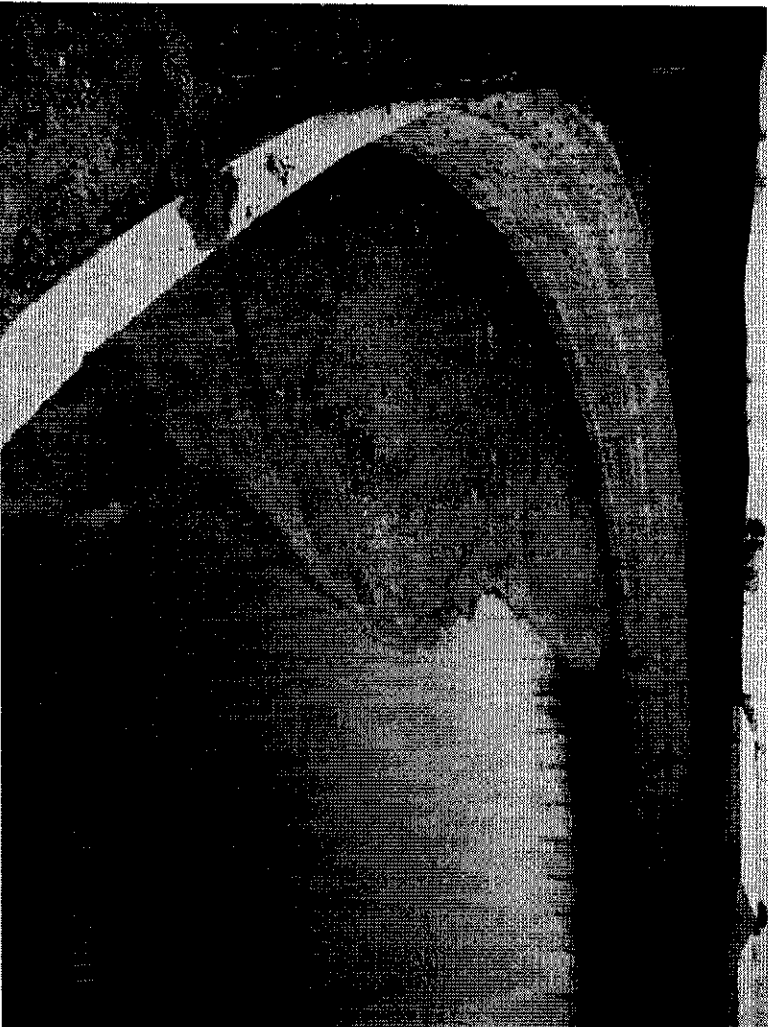
This is the facility's below ground waste storage tank. The tank is 10' deep and has a diameter of 180' allowing for a capacity of 1.6 Million gallons of waste to be stored. At this time there was approximately 7.5 ft of freeboard available. The structure did not have any issues that need to be addressed at this time.

Photograph #6. Concrete Basin, view is southeast.

Photograph #7. Concrete Basin, view is east.

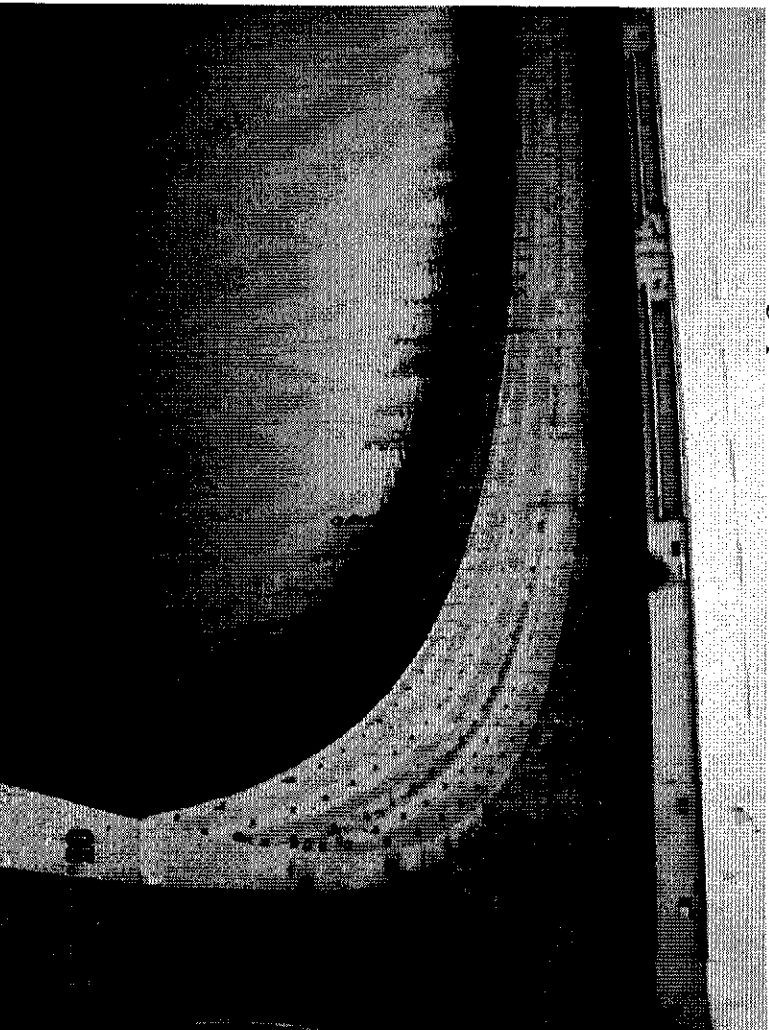
Photograph #8. Concrete Basin, view is south. Approximately 7.5' freeboard.

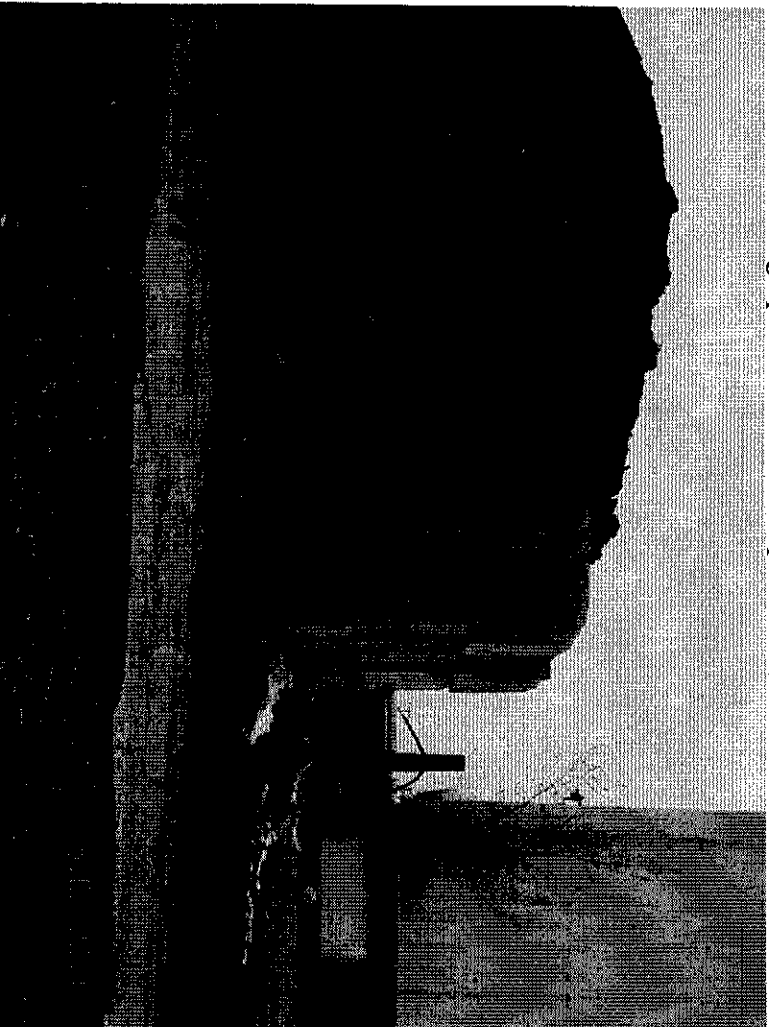
This area was a small three walled concrete blocked area on a concrete base, located directly to the west of the entrance area into the facility (see Figure 2.) Mr. Clark stated that approximately 30 dead sow where located in the compost area at this time. There is a record of death for the facility on the sow, but not on the piglets. There was no roof on this area, and a stain on the ground could be seen where leachate had discharged in the past (see attached photographs).

Photograph #10. Leachate from Death Compost Area.

1. Add a roof to this area.
2. Direct rainwater away from this area.
3. Catch all leachate to stop the discharge from this area.
